ARMY MILITARY PERSONNEL CENTER ALEXANDRIA VA
PRELIMINARY INVESTIGATION OF INTEGRATED BLUFF PROTECTIVE SYSTEM--ETC(U)
JUN 79 W D REYNOLDS

REPORT DOCUMENTATION PAGE		READ INSTRUCTIONS BEFORE COMPLETING FORM
1. REPORT NUMBER	2. GOVT ACCESSION NO.	3. RECIPIENT'S CATALOG NUMBER
4. TITLE (and Subtitle) Preliminary Investigation of Integrated Bluff Protective Systems for Lake Erie		5. TYPE OF REPORT & PERIOD COVERED Thesis, 1 JUN 1979

INVESTIGATION OF INTEGRATED BLUFF PROTECTIVE SYSTEMS FOR LAKE ERIE

A thesis submitted to The Ohio State University, Columbus, Ohio in partial fulfillment of the requirements for the degree of Master of Science.

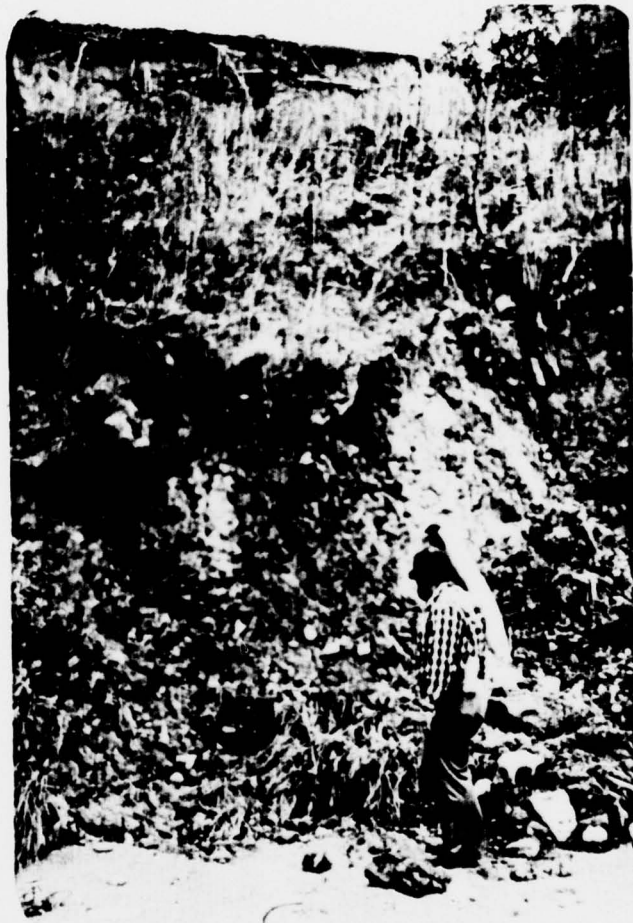
Photo 3
Broken Drain and Subsequent Seepage into Bluff

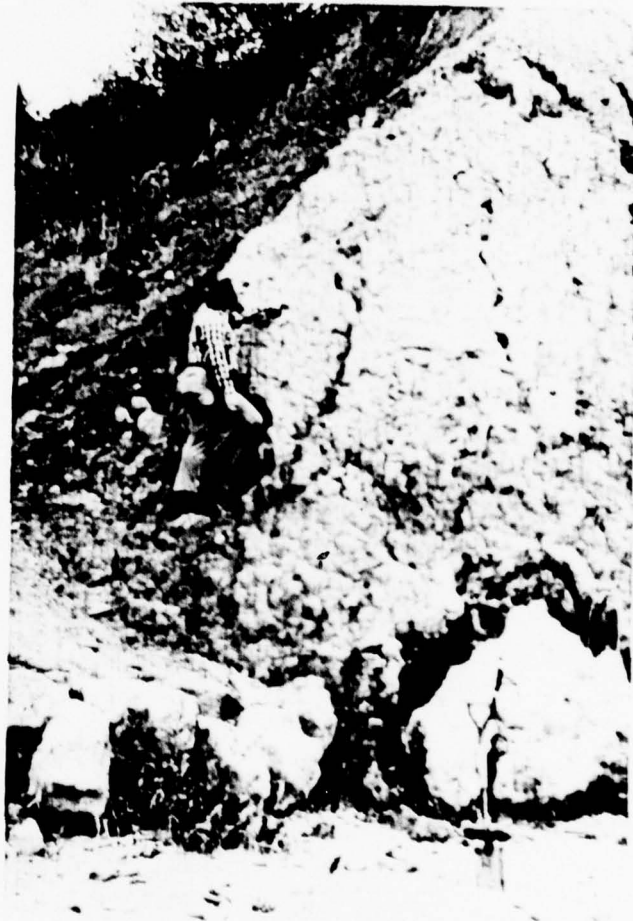
Photo 4
Slump Failure

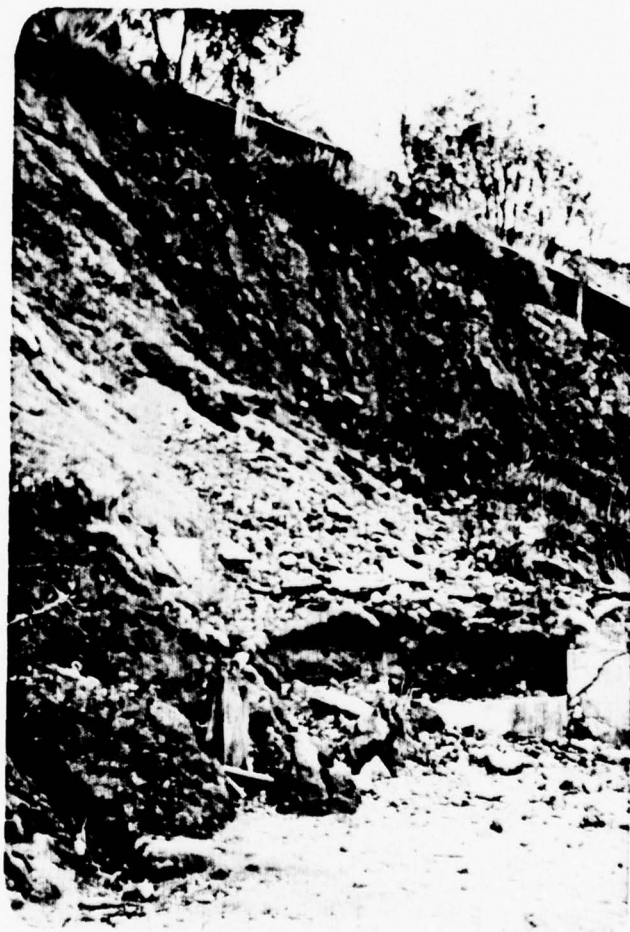
Photo 5

Groin (somewhere in vicinity of 655)		
				5' shore returns. Slump was caused by broken water main seeping water into bluff. Fill being placed to re-establish Shoreham Drive. Failure pending due to increased overburden.
		Stone Block Groinfield Bulkhead (12 ea)	#27, XI-69	Continuous seawall from Shore Club through 644. Appears to be no shore returns. Landward fill has toppled some drums and pushed others lakeward. No toe protection, filter, or support was placed under drums.

Slump Failure Caused by Overburden

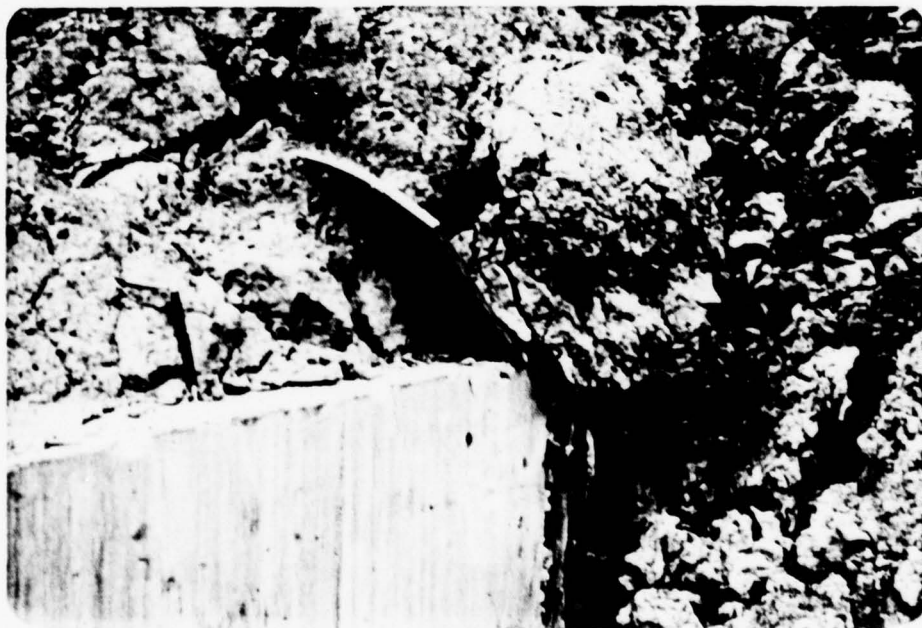
Although the $LI \ll 0$ thus indicating brittle failure, photos 6 and 7 show that the till can and does reach plastic conditions. In photo 6, the till has obviously flowed in a plastic condition. Photo 6 shows the till in its plastic condition. The NMC in the bluff at these locations was high enough to increase the LI of the fill to its plastic state.

Photo 6
Plastic Flow of Till

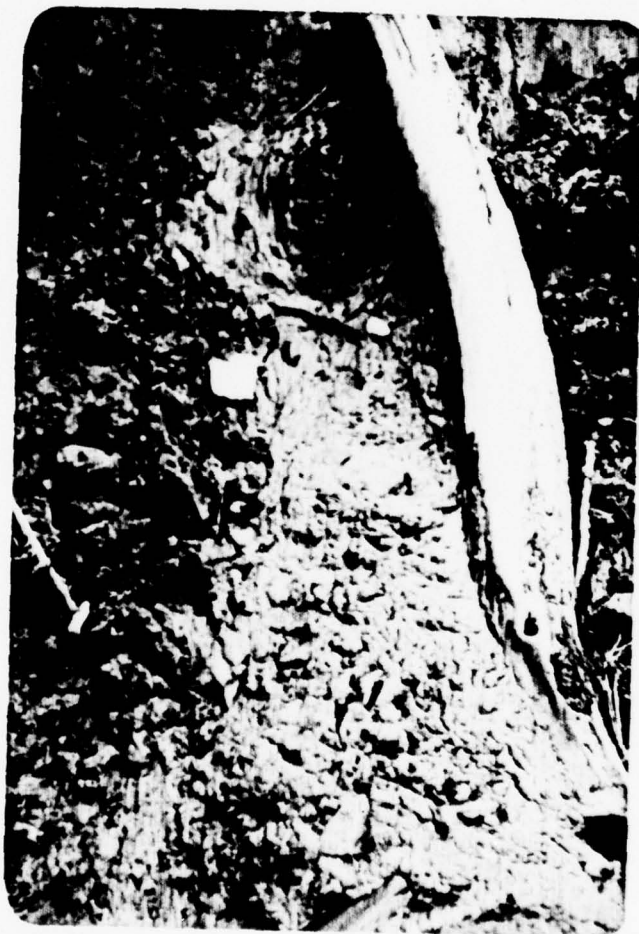
Photo 7

Till in a Plastic Condition

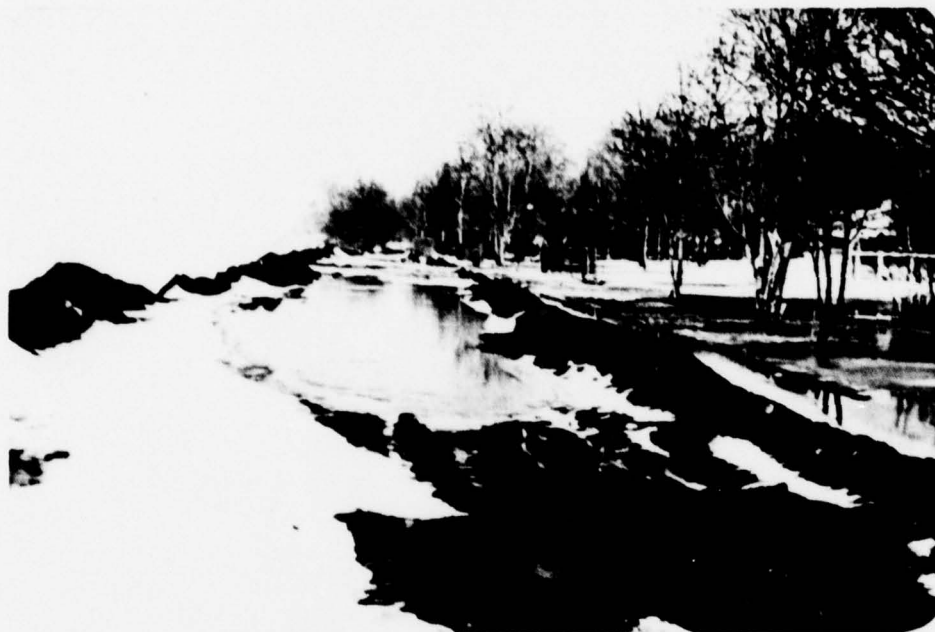
Standing Water on Top of Bluff

as porewater. The drain is surrounded by filter fabric to preclude the necessity for a graded gravel filter. The drain must be 2 ft wide in order to accomodate the 10 inch perforated flexible pipe. The existing drains may be connected directly to the collector pipe if at the correct depth. When the existing drains are at an incorrect depth, they should be cut and the part lakeward removed and placed at the new depth as shown in Figure 24. Since lightweight equipment (backhoe) must be used so close to the bluff edge, the depth of excavation is limited by the equipment capability. An 8 ft depth is used as an average value, but a deeper drain is prefereble if the equipment available has the capability. Flexible pipe, as shown in Photo 2, is used from the storm drain outlet to the bluff toe in order to divert runoff from the bluff face. The drain is placed 20 ft back from the bluff edge in order to allow for safe construction, to remain effective should recession continue, and to remove surface water before it percolates into the bluff. Photo 9 shows typical surface water that must be removed.
